National Aeronautics and Space Administration

# **Nuclear Compton Telescope Balloon Launch in Alice Springs, Northern Territory, Australia High Visibility Type B Mishap IRIS Case Number S–2010–119–00007 Volume I of II**

**Date of Mishap: April 29, 2010**

**Date of Report: September 7, 2010**

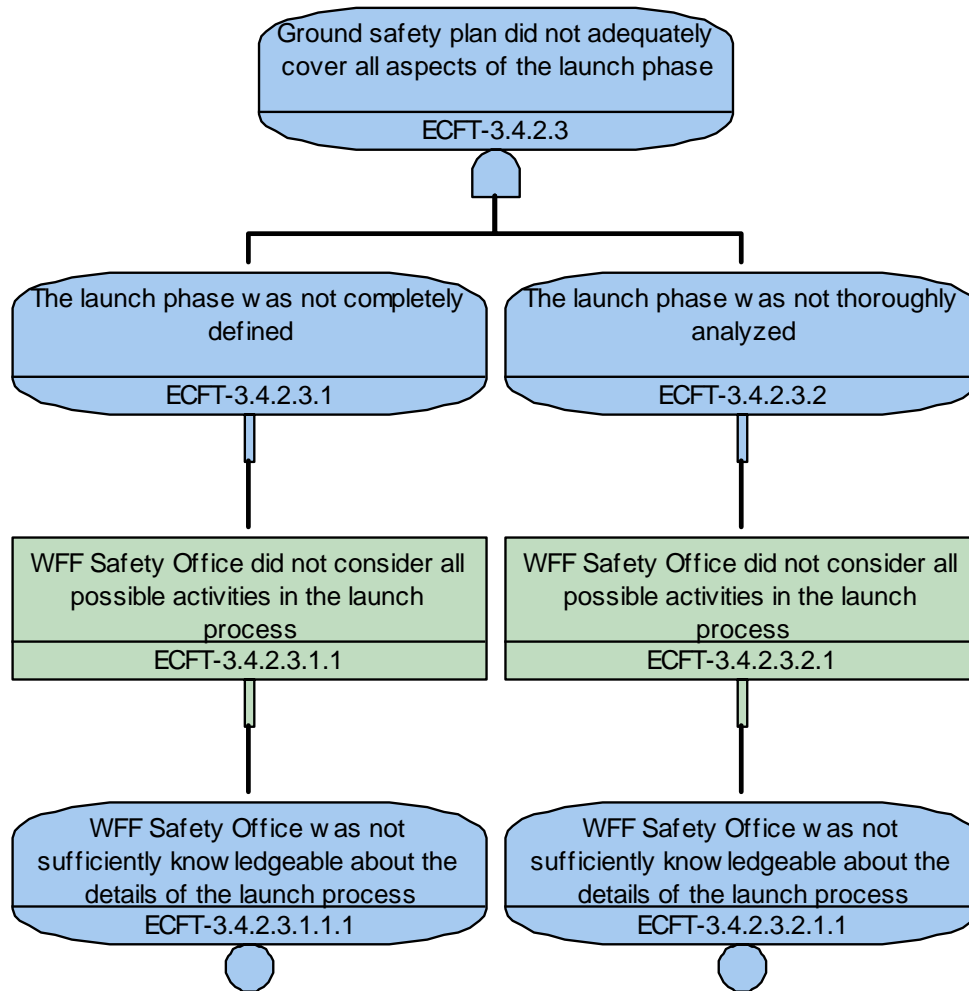
**Figure 81. The Ground Safety Plan Did Not Adequately Cover All Aspects of the Launch Phase**

- A. The launch phase was not completely defined. The process of moving the launch vehicle to chase the balloon, aligning the launch vehicle with the balloon, and attempting launch is not expressed in the Ground Safety Plan's description of the launch phase. This is indicated in documentation.

- a. WFF Safety Office was not sufficiently knowledgeable about the details of the launch process. In particular, hazards to the public were not identified in the ground safety plan.

- B. The launch phase was not thoroughly analyzed. Key hazardous elements of launch operations were not addressed for the process of chasing the balloon to attempt launch. This was evident from review of the Ground Safety Plan. The remainder of the logic follows as in item A.

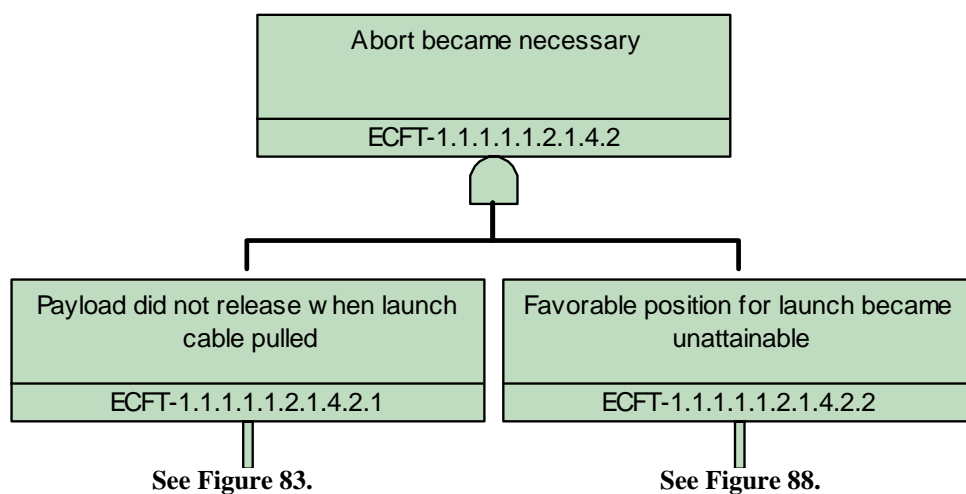
**Figure 82. Abort Became Necessary**

- A. Payload did not release when launch cable pulled. The pull force was insufficient to move the pin back from the pear ring and hence the payload remained attached to the launch vehicle. This was evident from video, test, and analysis.
  - B. Favorable position for launch became unattainable. With limited space based on the fence and the spectators, the balloon became too far offset from an appropriate position above the launch vehicle to ever be able to reach a position where launch would be feasible. This was evident from video and analysis.
-

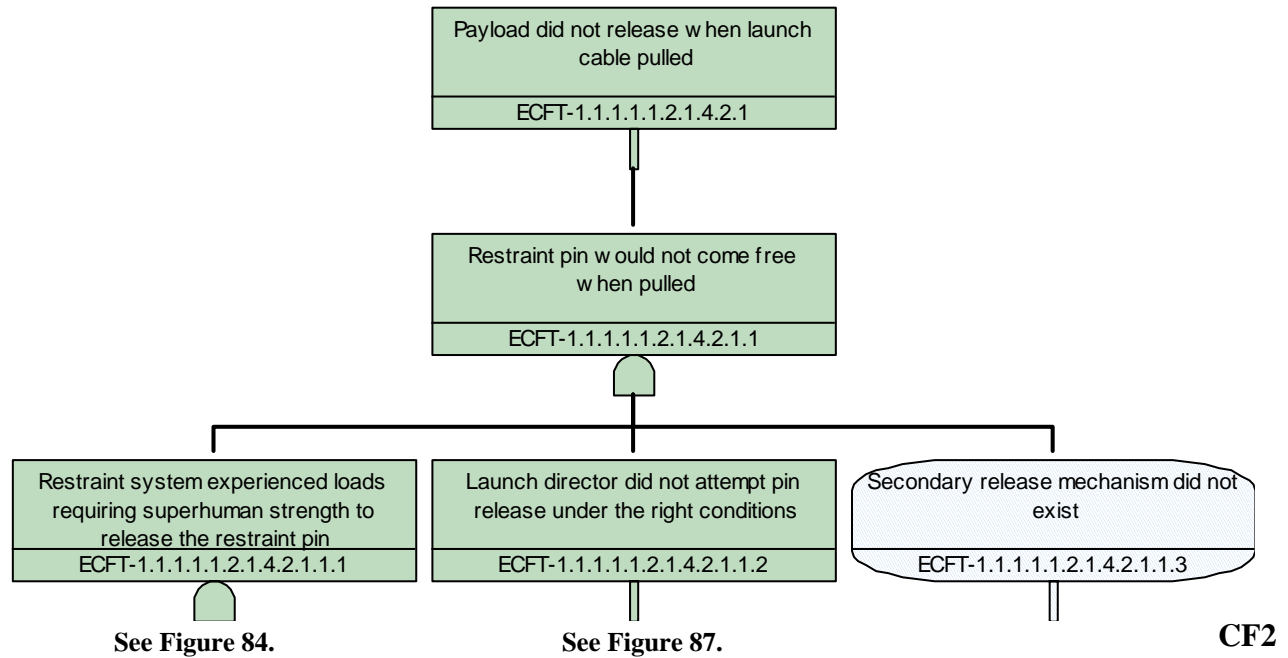
**Figure 83. Payload Did Not Release When Launch Cable Was Pulled**

- A. Restraint pin would not come free when pulled. The combined friction and spring force was higher than the force resolved at the pin from pulling the lanyard, according to video, analysis, and test.

2. Launch director did not attempt pin release under the right conditions. The angle of the balloon relative to the vertical from above the launch vehicle was too great, causing a significant shear force on the pin, resulting in a significant friction force, preventing its release. This was indicated from analysis.

3. A secondary release mechanism did not exist. Had there been a secondary mechanism that was not subject to the shear and friction force combination that limited the launch director's ability to release the pin, the payload may have released successfully. Analysis shows that the catenary angle, while large, would not likely have caused the payload to pendulum down and hit the ground upon launch. **Contributing Factor 2.** This leads to root cause R6 in the next block and is not shown again here.

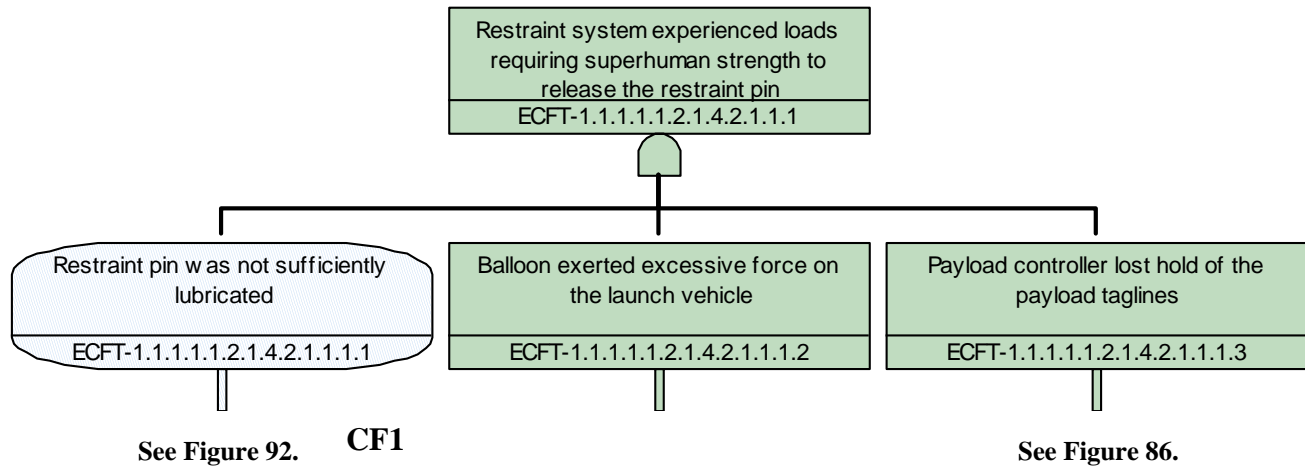
**Figure 84. Release Mechanism Experienced Loads Requiring Superhuman Forces to Enable Release**

- A. Restraint pin was not sufficiently lubricated. While there is no evidence of requirements to lubricate the pin, without lubricant, the amount of friction force due to shear force imparted by horizontal motion or pull of the balloon can be arbitrary, and require a tremendous force to overcome. This was evident from analysis. **Contributing Factor 1.**

- B. Balloon exerted excessive force on the launch vehicle. The balloon being significantly ahead of the vehicle caused a large horizontal force on the launch vehicle. This was evident from video and analysis. The logic continues the flow in the middle branch of Figure 54.

- C. Payload controller (aka the payload launch assistant) lost hold of the taglines. When the straps used to stabilize the payload during launch were lost, it created a dynamic load on the launch mechanism adding to the force on the pin that the launch director would have to overcome for successful launch. This was evident from video and analysis.

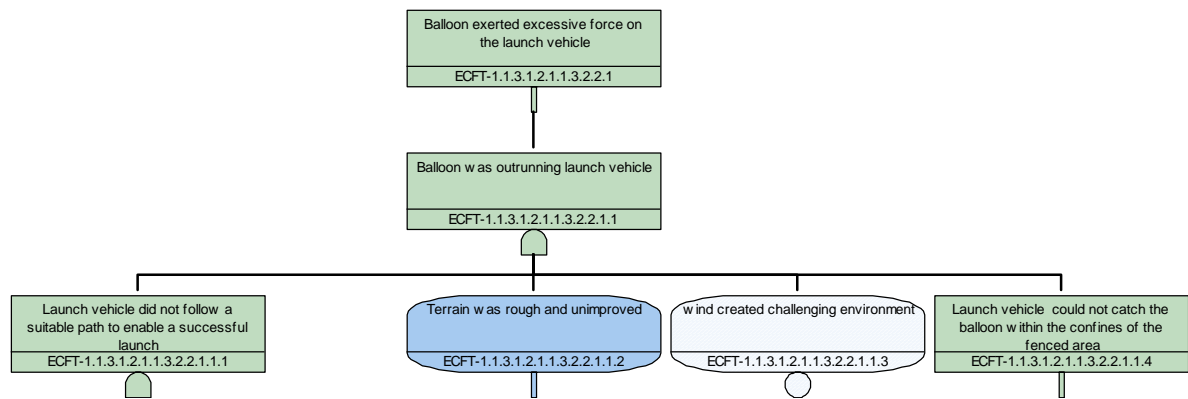
**Figure 85. Balloon Exerted Excessive Force on the Launch Vehicle**

- A. The balloon was outrunning the launch vehicle. The balloon was ahead and getting further ahead and more and more challenging to catch.
1. Launch vehicle did not follow a suitable path to enable a successful launch. Some of the turns taken by the launch vehicle caused the vehicle to lose ground on catching the balloon. This is evident from interviews and video.
  2. Terrain was rough and unimproved. Logic in Figure 63 follows and is not repeated here.
- Intermediate Cause I8.**
3. The launch vehicle could not catch the balloon within the confines of the fenced area. The combination of speed limitations of the crane and the limited travel range of the vehicle due to the layout of the flight train and limited area prevented the launch vehicle from being able to catch the balloon (block not shown). This is evident from videos and documentation.

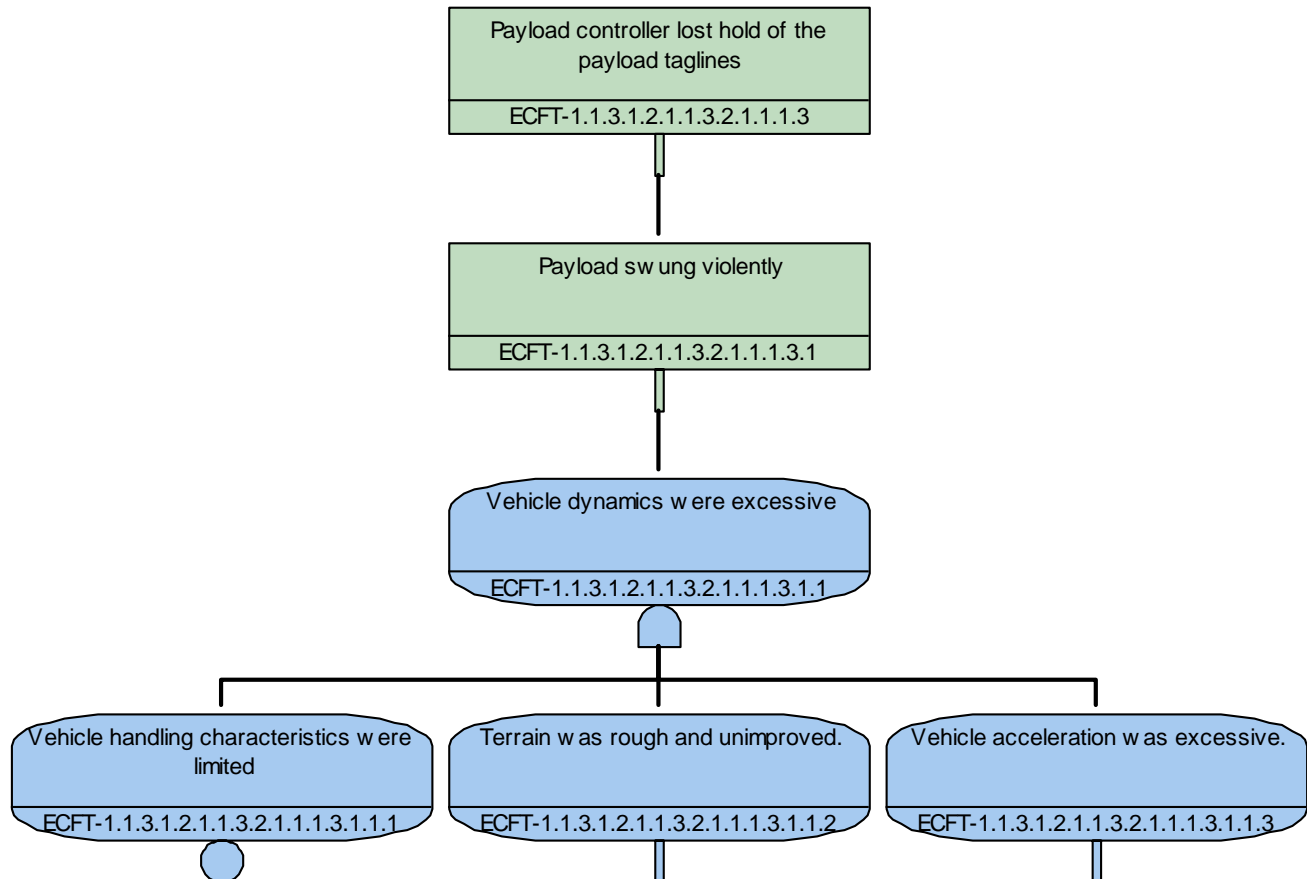
**Figure 86. Payload Controller Lost Hold of the Taglines**

- A. The payload swung violently, as observed in video evidence. This caused additional stresses on the hardware and made it more difficult to successfully release the payload from the vehicle.
1. Vehicle dynamics were excessive. Motions of the vehicle were imparting into the payload, as apparent from video evidence.
    - a. Vehicle handling characteristics were limited. There was, expectedly, a finite amount of speed, shock absorption, and lateral control capability.
    - b. Terrain was rough and unimproved. (See Figure 63.)
    - c. Vehicle acceleration was excessive. Specifically the deceleration due to a sudden stop caused a jolt, as evident from the video. The sudden stop was in order to make a launch attempt (block not shown).

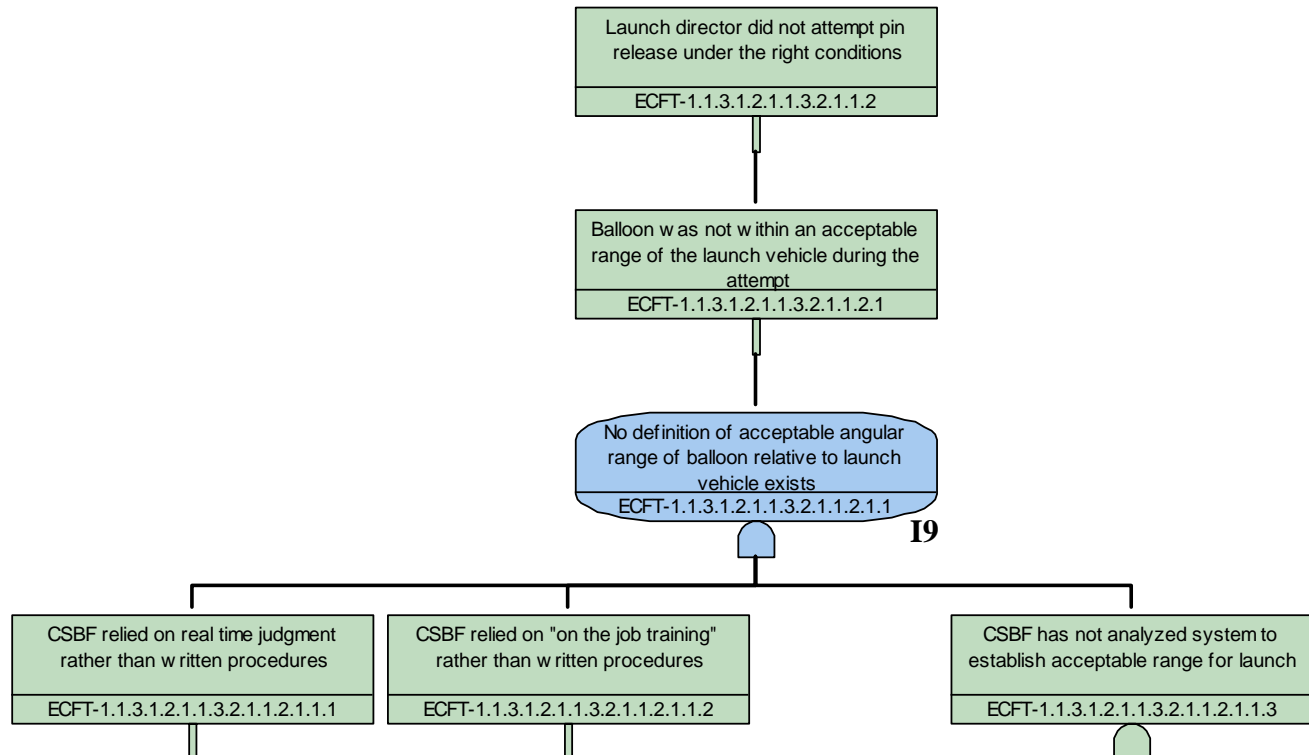
**Figure 87. Launch Director Did Not Attempt Release Under the Right Conditions**

A. Balloon was not within an acceptable range of the launch vehicle during the attempt. Analysis and test showed that the large angle with the vertical caused a significant shear force and hence friction force, which ultimately prevented the pin from releasing.

- a. CSBF relied on real-time judgment rather than written procedures. The general approach has been to train the launch crew in a general sense and have them respond to the events with good judgment. This is evident from documentation and interview. The rest of this branch follows with the logic in Figure 60.
- b. CSBF relied on “on-the-job training” rather than written procedures. On-the-job training is used in place of explicit rules and procedures. This is evident from documentation and interview. The rest of this branch follows with the logic in Figure 60.
- c. CSBF has not analyzed the system to establish the acceptable range for launch. There is no evidence that anything but training and visual determination is used to decide when launch can take place. The rest of this branch leads to the same cause as determined from Figure 60.

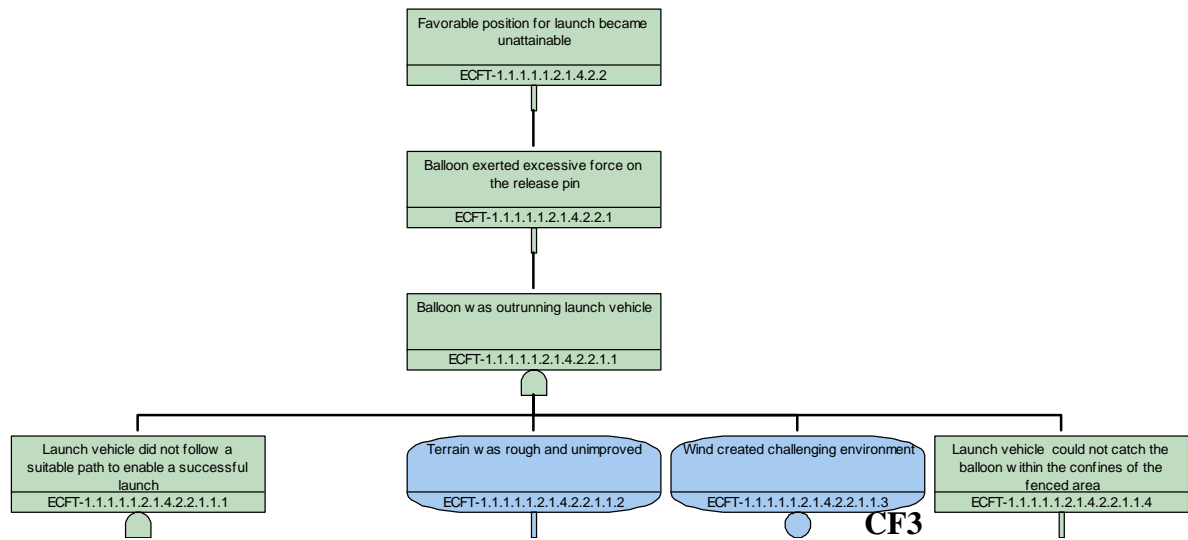
**Figure 88. A Favorable Position for Launch Became Unattainable**

- A. Balloon exerted excessive force on the launch vehicle. This branch follows essentially the same logic path as that in Figure 84, with the addition of the “wind created challenging environment” block. Although the wind was not greater than allowable specifications, according to interview, it was strong enough to make the process of catching the balloon more challenging (**Contributing Factor 3**).

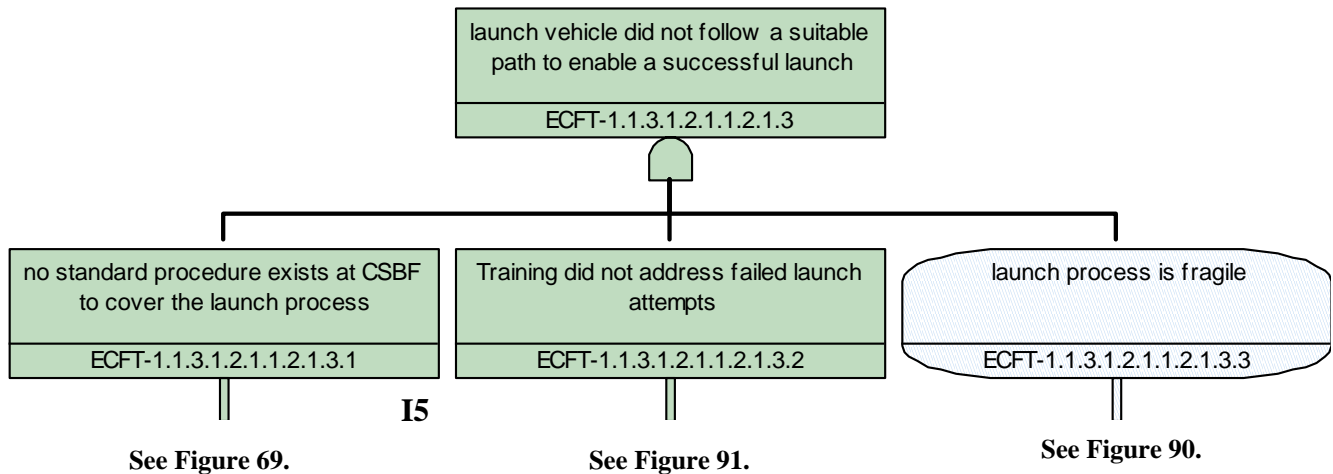
**Figure 89. Launch Vehicle Did Not Follow a Suitable Path to Enable a Successful Launch**

- A. No standard procedure exists at CSBF to cover the launch process. Given that the launch process is a hazardous operation, the contract with CSBF requires written procedures. This is evident from interview and documentation. **Intermediate Cause I5**

- B. Training did not address failed launch attempts. In particular, there is insufficient guidance for dealing with any anomalous or contingency situations. This is evident from interview and documentation. **Intermediate Cause I6**
- C. The launch process is fragile. Without explicit procedures and due to the dependency on visual assessment and good judgment, the launch process is highly sensitive to errors in judgment, perception, and visualization. This is evident from interview and documentation. **Contributing Factor 4**

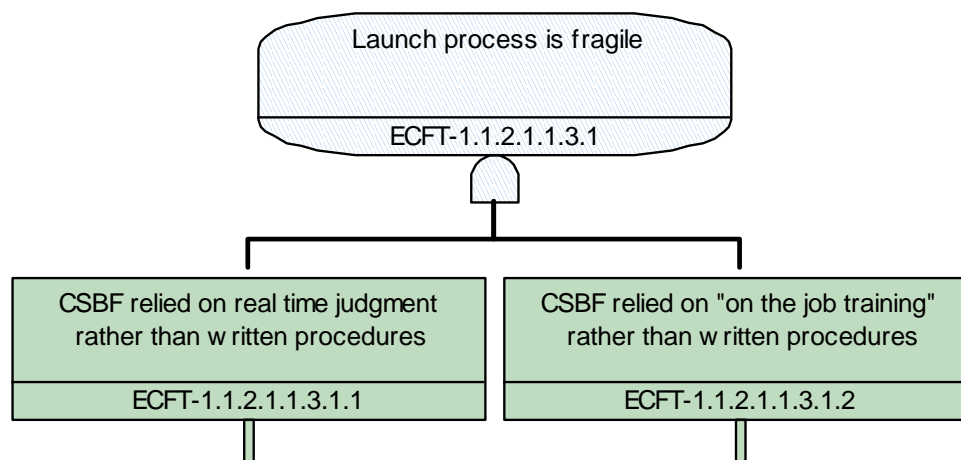
**Figure 90. The Launch Process Is Fragile**

- A. CSBF relied on real-time judgment rather than written procedures. Interview and documentation review indicate that the process of launching the balloon is not something that is written down, but rather is something of an art based on the observation of the surroundings and some general, unwritten guidelines. This block next leads to Root Cause R6: Reliance on past success has become a substitute for good engineering and safety practices.
- B. CSBF relied on “on-the-job training” rather than written procedures. Interview and documentation review indicate that on-the-job training is the means for conveying the process of launching the balloon, rather than writing down a procedure. This block next leads to Root Cause R6 as well.

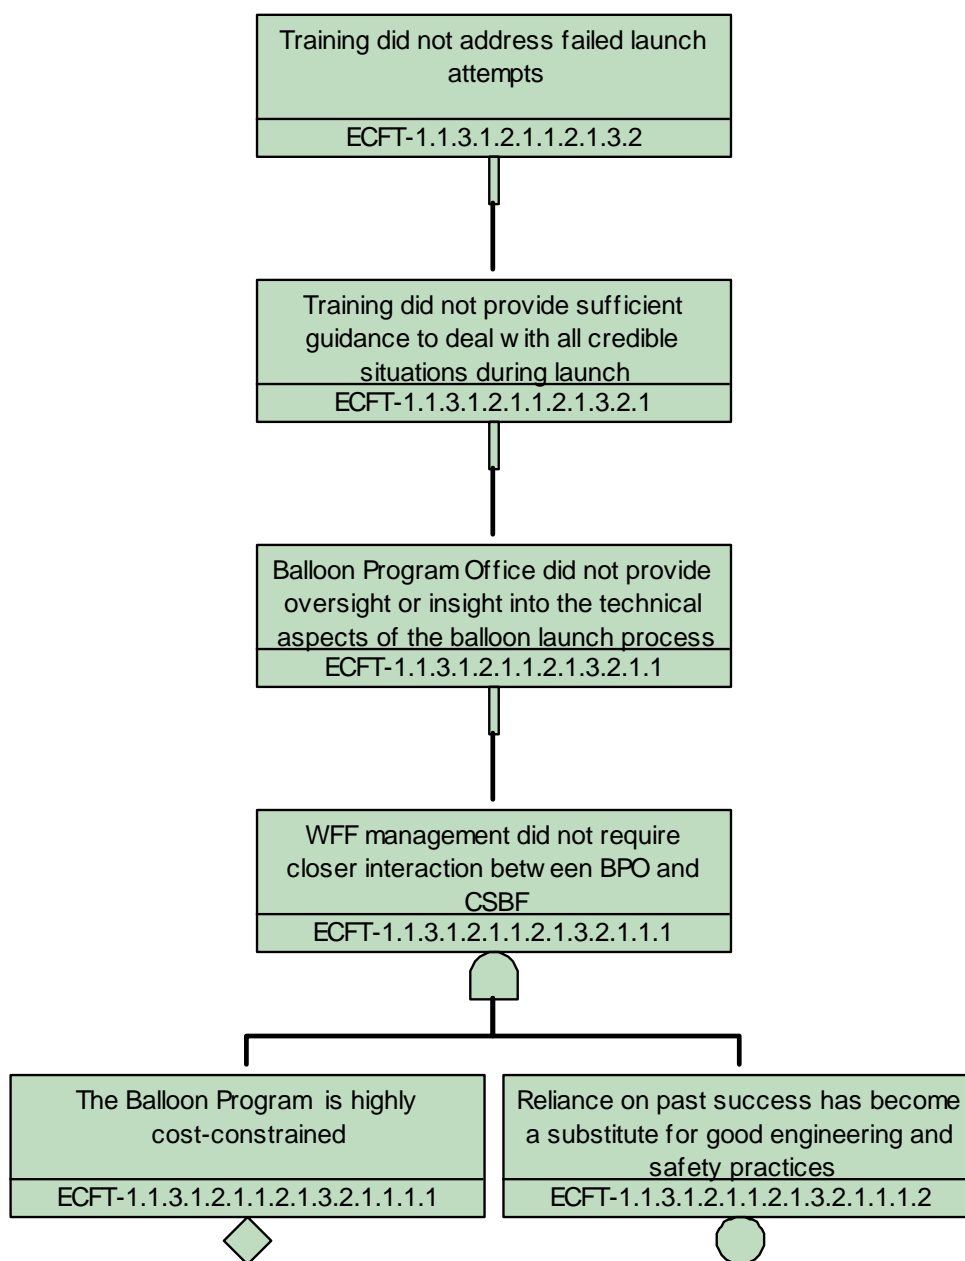
**Figure 91. Training Did Not Address Failed Launch Attempts**

- A. Training did not provide sufficient guidance to deal with all credible situations during launch. Interviews indicated that there is no specific training element to deal with anomalies or unexpected occurrences. The rest of the branch follows Figure 60.

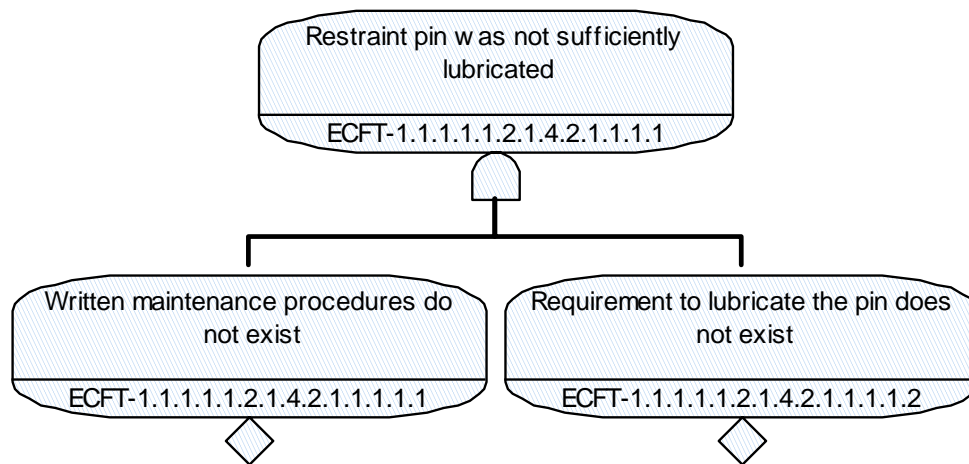
**Figure 92. Restraint Pin Was Not Sufficiently Lubricated**

- A. Written maintenance procedures do not exist. No evidence of maintenance was provided upon request to the MIB.
- B. A requirement to lubricate the pin does not exist. There was no information provided nor that provided from interviews to indicate lubrication requirements.

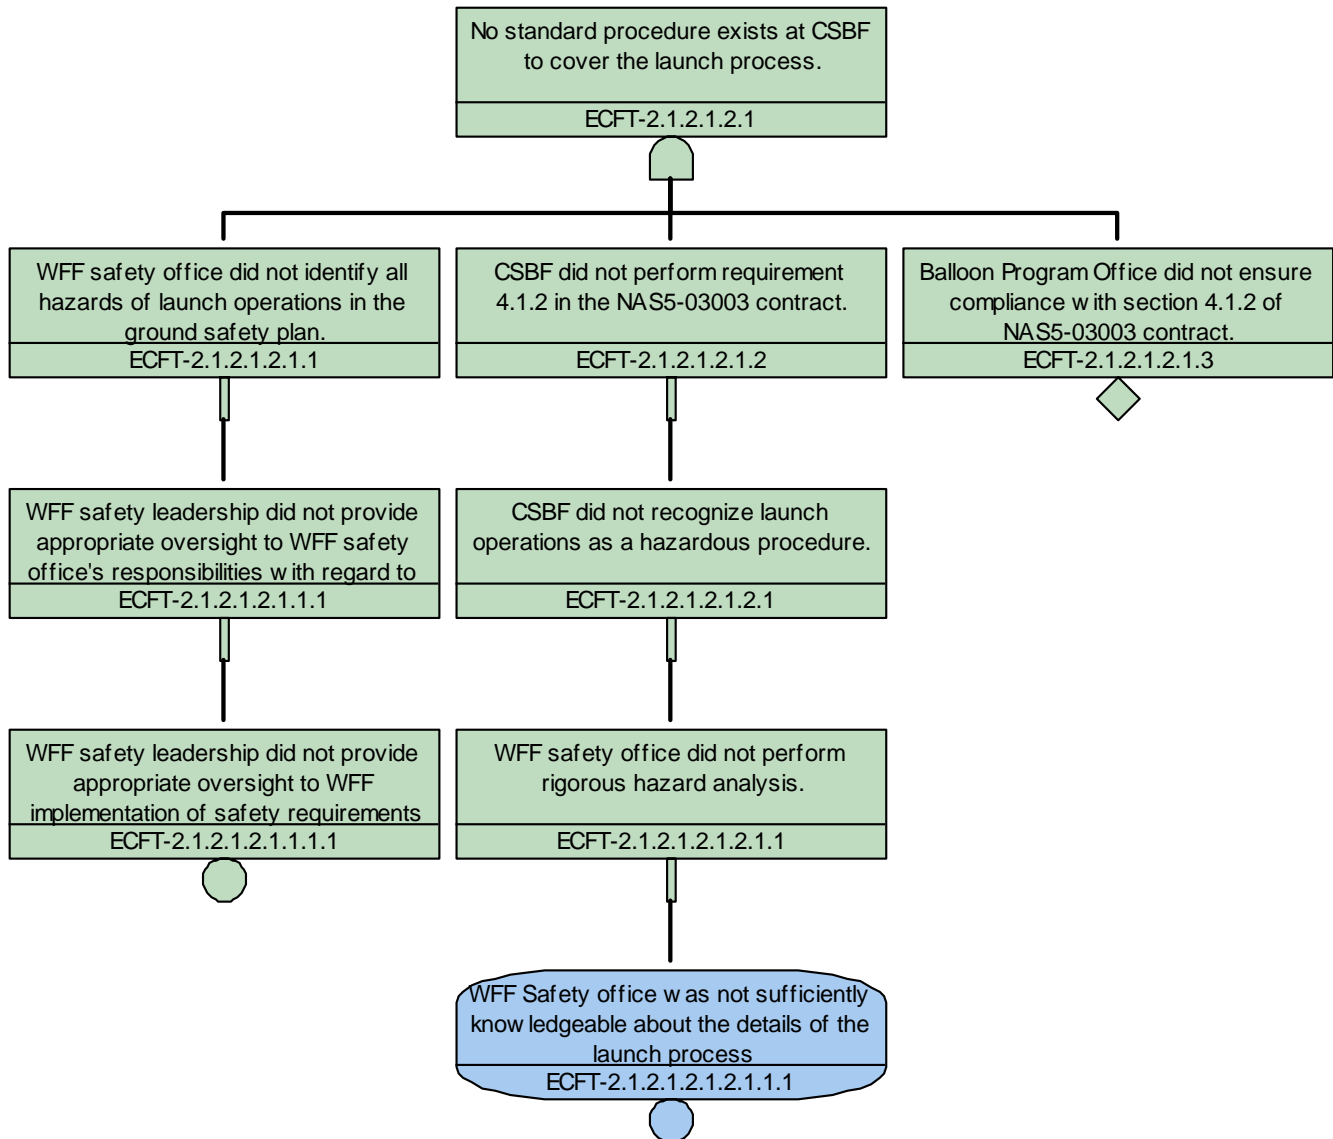
**Figure 93. Repeated From PUO—No Standard Procedure Exists at CSBF to Cover the Launch Process**

Cause: E&CFT-2.1.2.1.2.1 No Standard procedure exists at CSBF to cover the launch process. This branch of the E&CFT for the PUO is reproduced in Figure 93.

This cause traces down to three causes including 1) WFF Safety Office not identifying all hazards, 2) CSBF not establishing written procedures for hazardous operations and the 3)BPO not ensuring compliance with the NAS-03003 contract (which requires written procedures for hazardous operations).

The focus of these three intermediate causes for the PUO is to address the hazards and hazardous operations that target humans, specifically the public. For SUO1, the interpretation of these three intermediate cause and all causes that flow down from them must be expanded to include the assets as targets for the hazards. Likewise, causes associated with safety oversight must include safety of the assets.
